The Late Antique wreck od Debeljak cove (Cape Kamenjak, Premantura, Istria)

Giulia Boetto, Vincent Dumas, Ida Koncani Uhač, Pierre Poveda, Marko Uhač

Giulia Boetto, Vincent Dumas, Ida Koncani Uhač, Pierre Poveda, Marko Uhač. The Late Antique wreck od Debeljak cove (Cape Kamenjak, Premantura, Istria). *Histria archaeologica : časopis arheološkog muzeja istre : bulletin du musée archéologique d'Istrie*, 2022, 2021 (52), pp.155-186. halshs-03909500

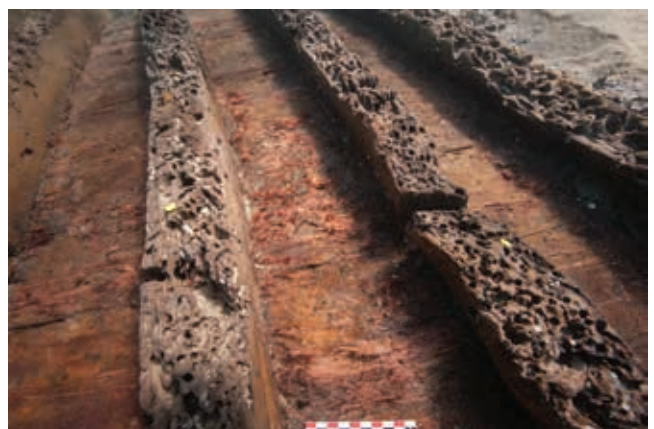
Sl. 16 Poprečni presjek V oblikovanog rebara F1116 i F6S (fotografija: L. Damelet).

Floor timber F6S, half-frames F5S and F7S at the east end of the south side (Assemblage no. 2) and half-frame F116 of Assemblage no. 7 are gently V-shaped at their base (Figs. 13, 28 and 29). A dislocated V-shaped floor timber (W115) was also found near transitional timber K. Due

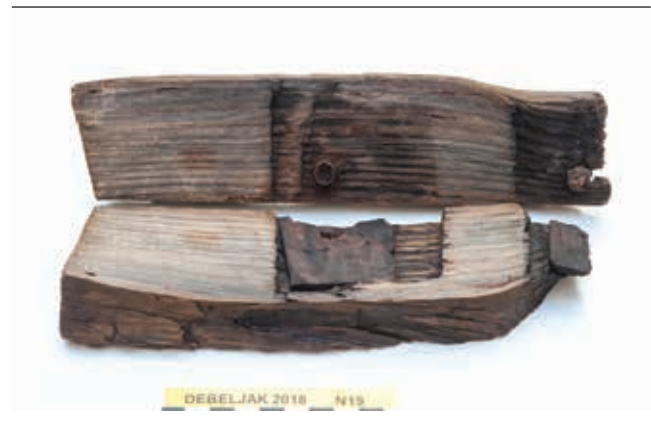
Sl. 23 Ulomak platice sa spojem jezičac i utor: utor je blago trapezast i veći od jezičca (fotografija: L. Damelet).

Measurements of the fasteners were taken on some of the individual pieces and, where possible, on the hull (Figs. 23–25). The mortises are larger than the tenons. They are, on average, 6.2 cm wide, 8 mm thick, 4.5 cm deep, and spaced 12 cm apart (side-to-side). The pegs are tapered (inner diameter 11 mm, outer diameter 9.2 mm) and spaced 10 cm apart (centre-to-centre). The tenons are 8.2 cm long, 4.7 cm wide, 6 mm thick. One tenon (DE18/N10), found detached, is longer than the others (13 cm) and was secured by three pegs. It was used to join three planks at an oblique scarf or a stealer (Fig. 25).

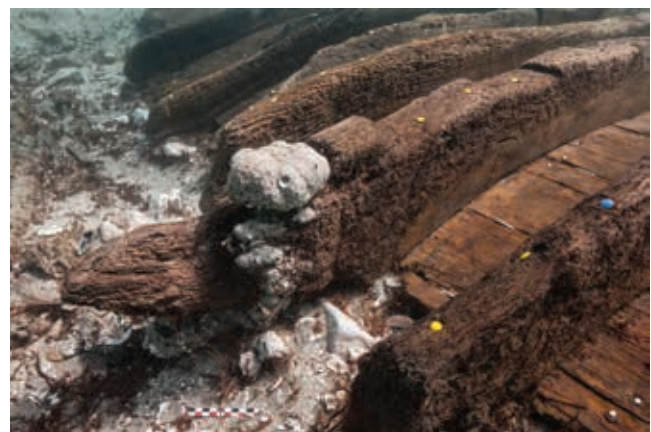
Sl. 28 Pogled sa sjeverozapada na rebro F6S: gornja površina je obrađena s utorima za smještaj dohrptenice i proveze (nisu sačuvane); kongrecija je gornji dio svornjaka (fotografija: L. Damelet).
Fig. 28 View from the north-west of floor timber F6S: the upper surface is carved with recesses to house a sister keelson and a stringer (not preserved); the concretion is the upper part of the bolt (photo: L. Damelet).

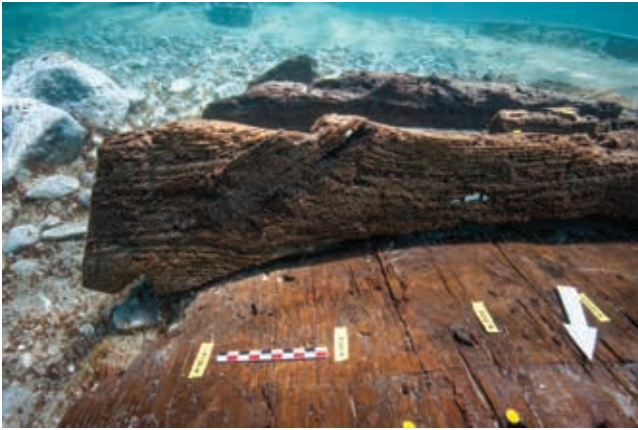
Sl. 29 Polurebrenica F116 s trokutastom rupom za slivnicu i udubljenjem za smještaj kobilice, pogled sa sjevera (fotografija: L. Damelet).
Fig. 29 View from the north of half-frame F116 with a triangular limber hole and a recess to house a keelson (photo: L. Damelet).

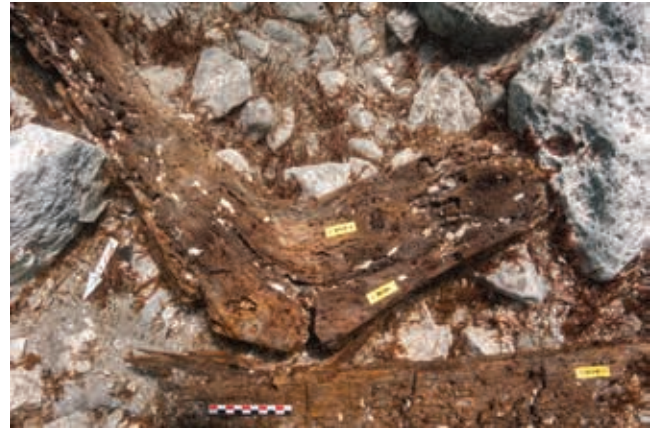
Sl. 30 Komad drva W115 iskorišten za učvršćenje rebra F116 (fotografija: L. Damelet).
Fig. 30 Floor timber W115 and its filling piece F116 (photo: L. Damelet).

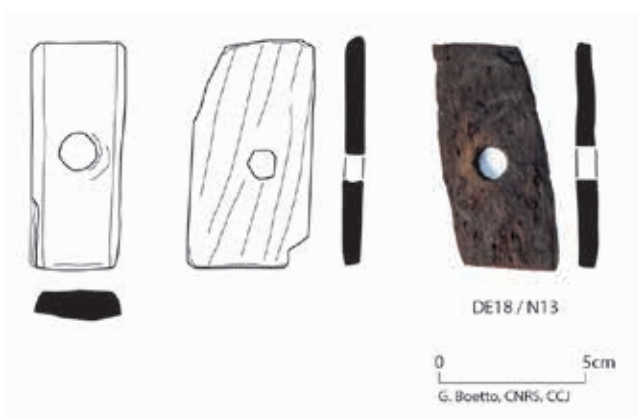
Sl. 31 Tri drvena umetka (fotografija: L. Damelet; crtež: G. Boetto).
Fig. 31 Three wedges (photo: L. Damelet; drawing: G. Boetto).

Three small rectangular pieces of wood with a hole in the middle (average 8 cm long, 3.7 cm wide, 8 mm thick) were found during the excavation (Fig. 31). These are probably wedges that have been inserted under some frames.
